### **APPENDIX A – BC BUILDING SCIENCE EXTERIOR TEST AREA OBSERVATIONS**

### **APPENDIX C – PHOTOGRAPHS**

Westview Place

1166 West 11<sup>th</sup> Avenue, Vancouver

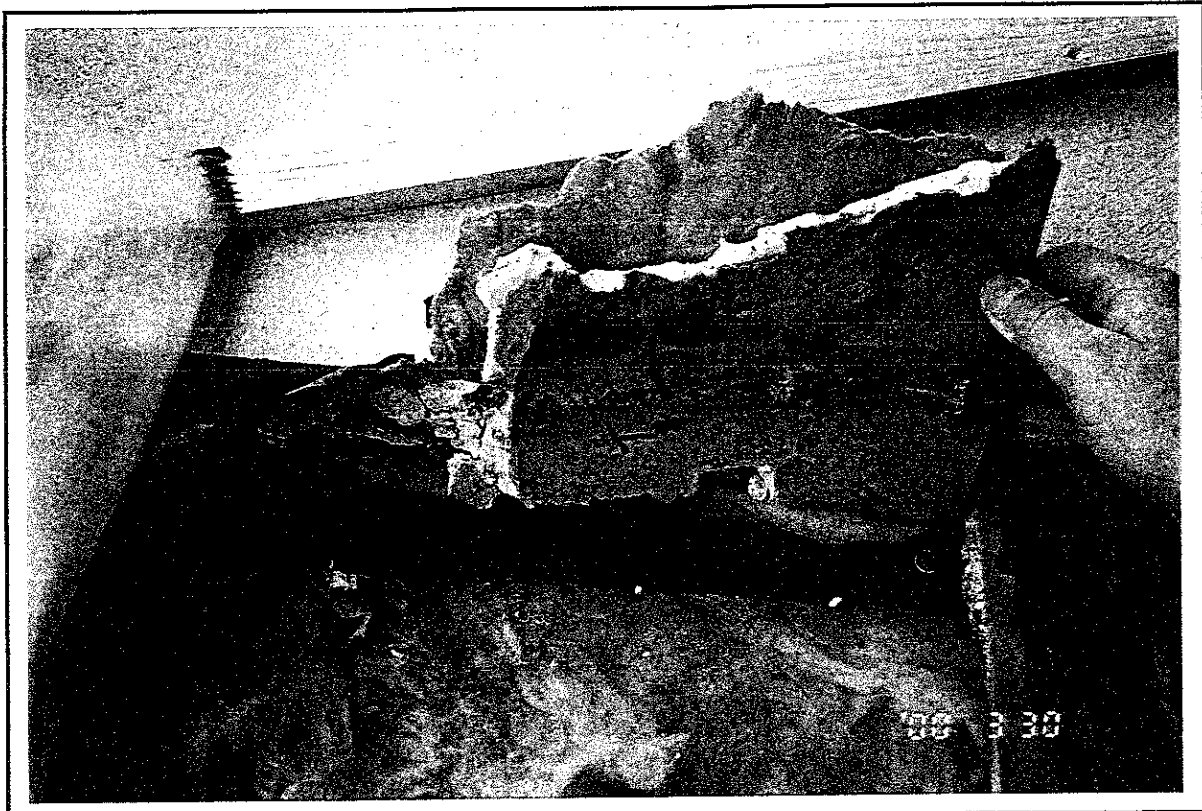
Photo #3 – Test Area #2 – Mouldy gypsum sheathing & corroded steel studs

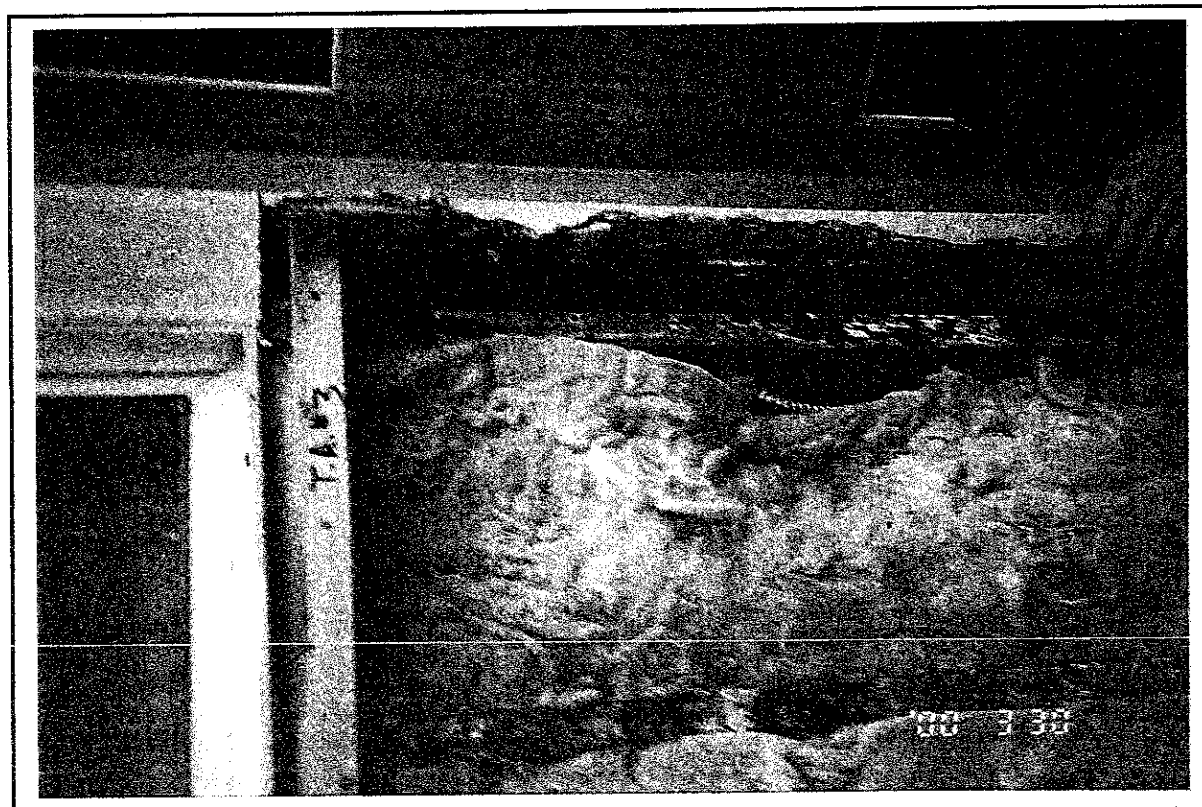
A3	<ul style="list-style-type: none"> <li>South end of West wall, at angled wall outside bedroom of Unit 203.</li> </ul>	<ul style="list-style-type: none"> <li>Gypsum sheathing stained and deteriorated.</li> <li>Steel studs partially corroded, mostly concentrated at corner.</li> </ul>	✓
A4	<ul style="list-style-type: none"> <li>South end of West wall at balcony of Unit 204</li> </ul>	<ul style="list-style-type: none"> <li>Gypsum stained and saturated but not deteriorated.</li> <li>Steel studs partially corroded, mostly concentrated at balcony parapet where cap flashing not installed and at saddle interfaces.</li> </ul>	✓
A5	<ul style="list-style-type: none"> <li>South wall, West end, adjacent to concrete column build-out, outside kitchen of Unit 204.</li> </ul>	<ul style="list-style-type: none"> <li>Gypsum sheathing deteriorated and crumbled apart at most locations once stucco removed.</li> <li>Steel studs and steel furring at concrete column extensively corroded to the point that some screws could be pulled out by hand.</li> <li>Ant nest at 2 floors above grade.</li> </ul>	✓

Photo #4 – Test Area #3 – Corroded steel studs

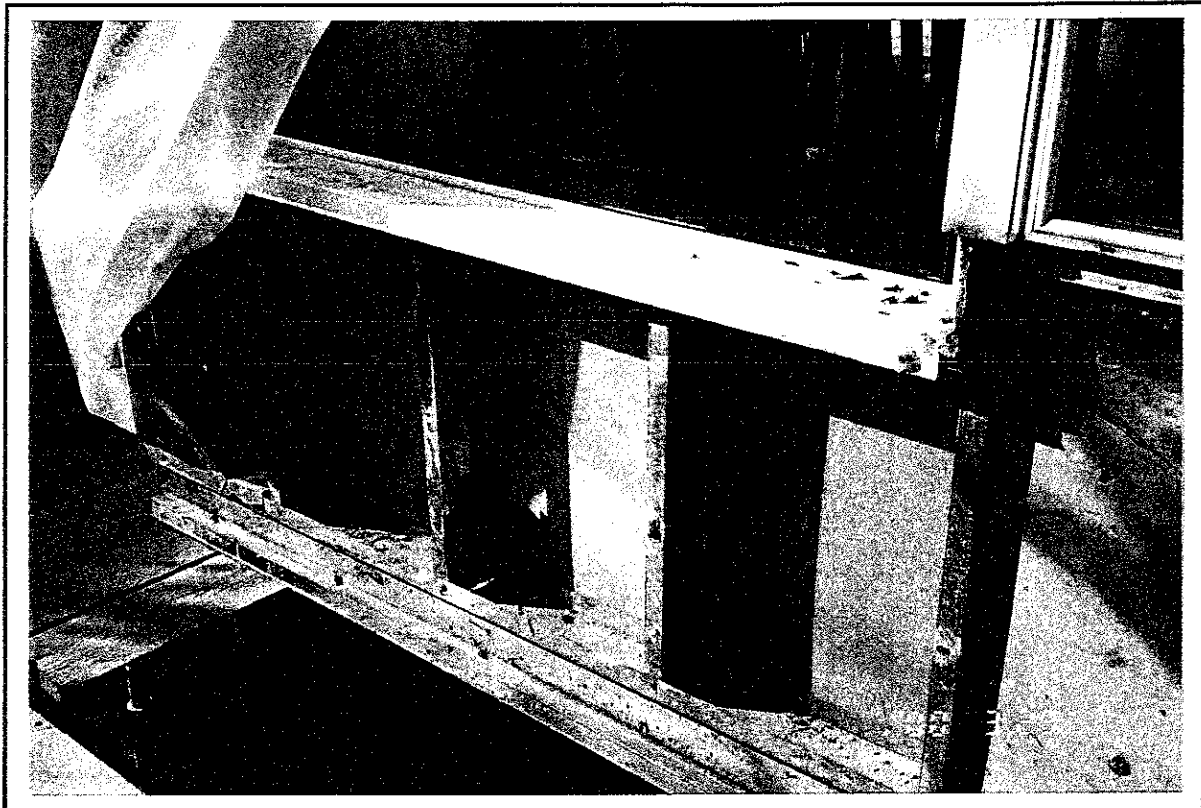
Photo #5 – Test Area #4 – Balcony of 204

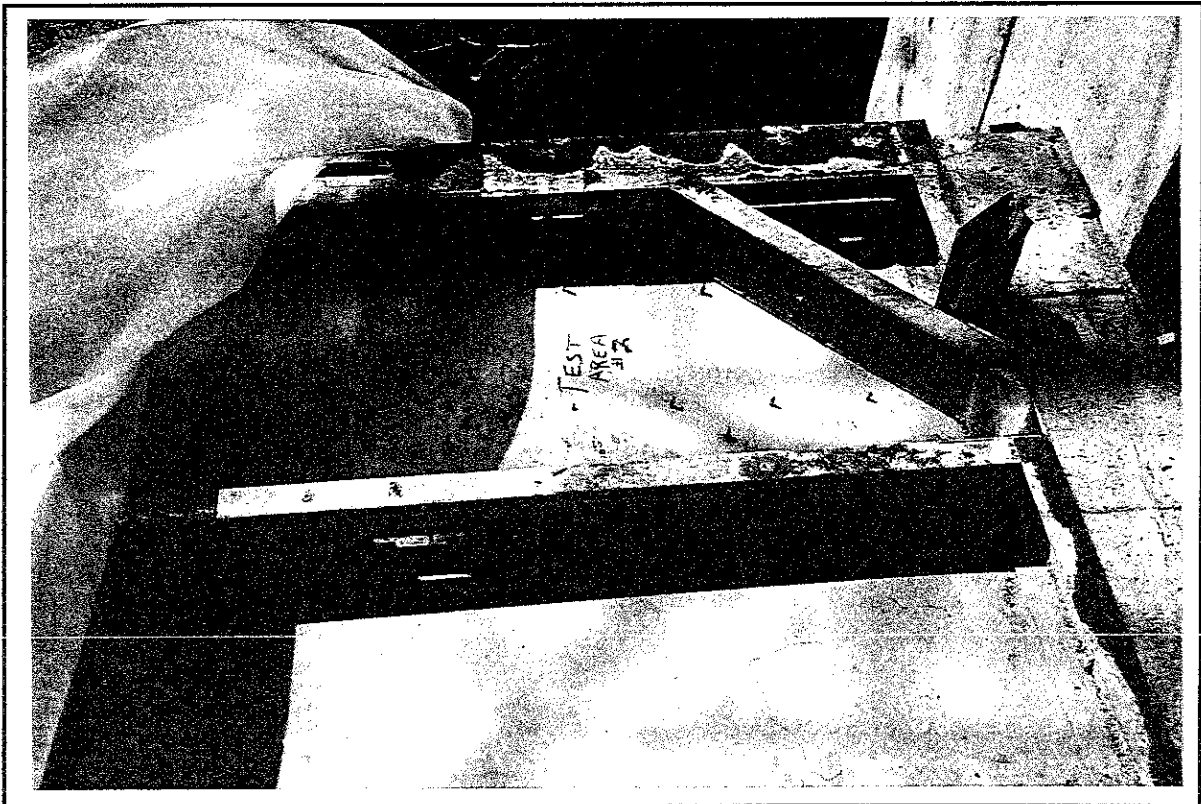
Photo #6 – Test Area #4 – Balcony of 204

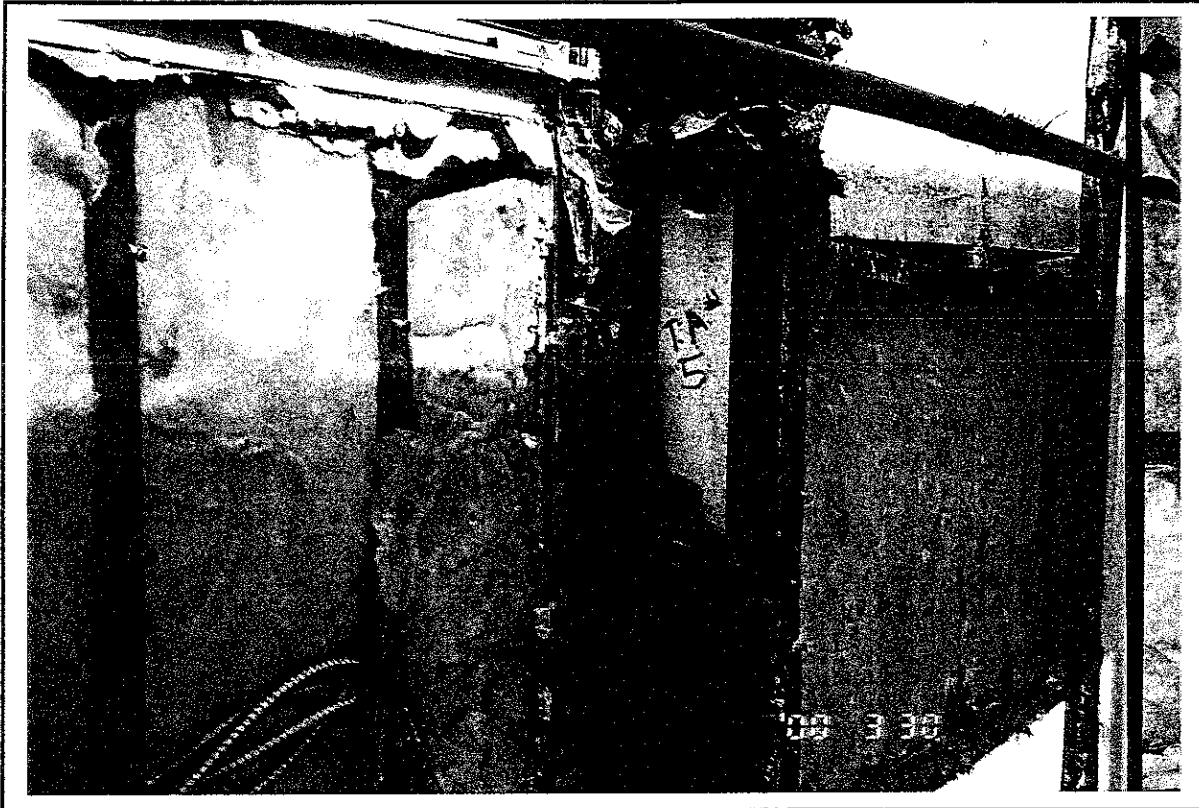
Photo #7 – Test Area #5 – Corrosion of steel studs at column & below window

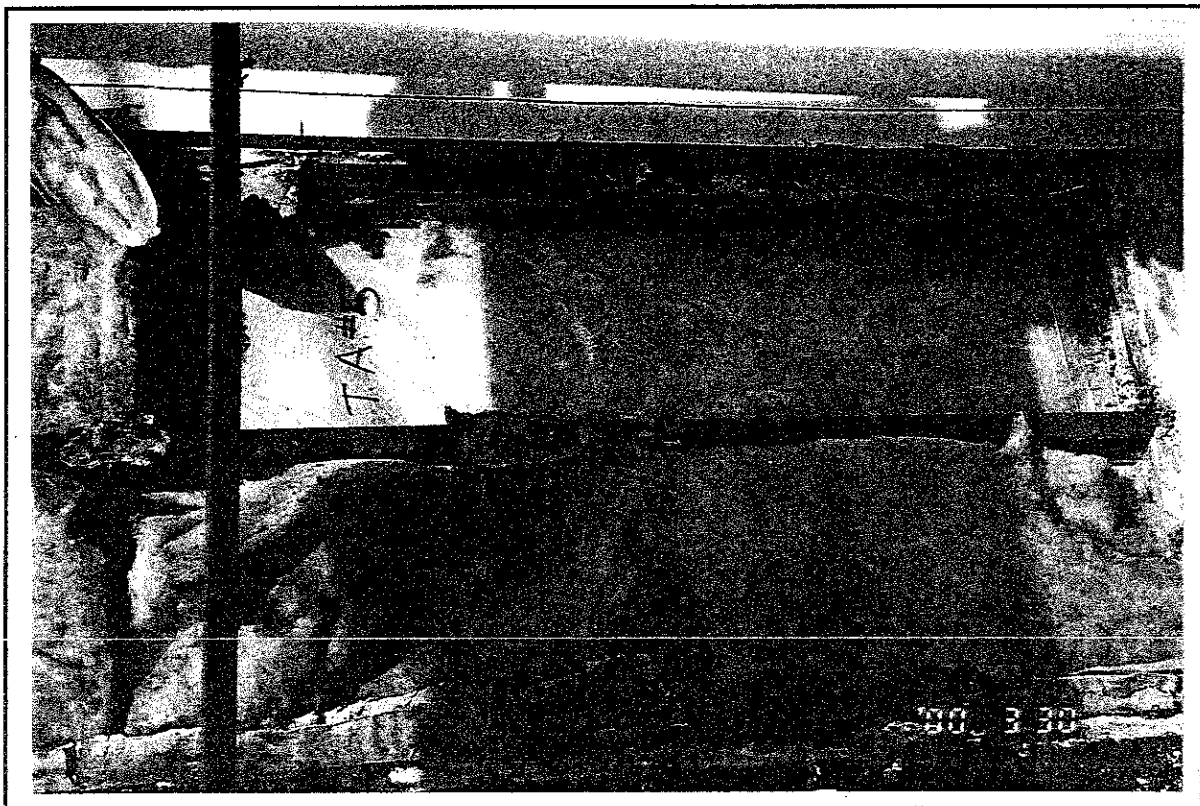
Photo #8 – Test Area #5 – Corrosion of steel studs

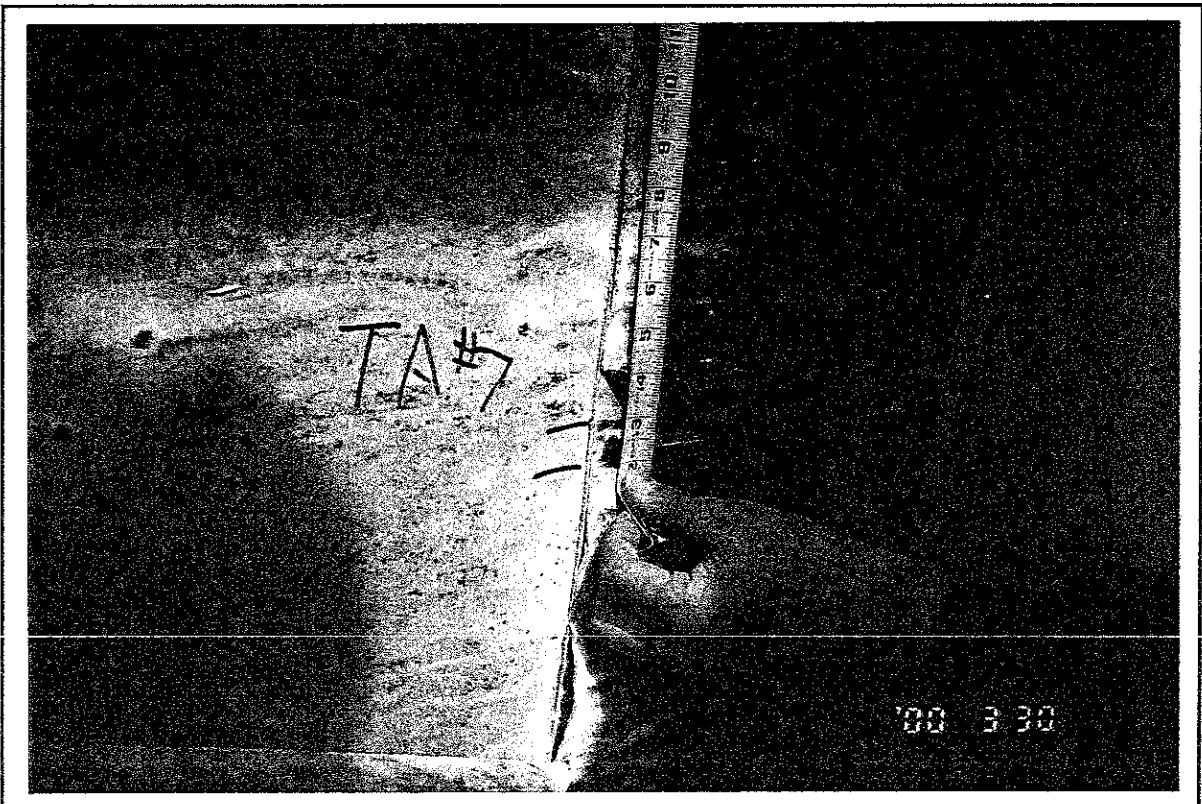
Photo #10 – Test Area #7 – poor installation of sheathing paper

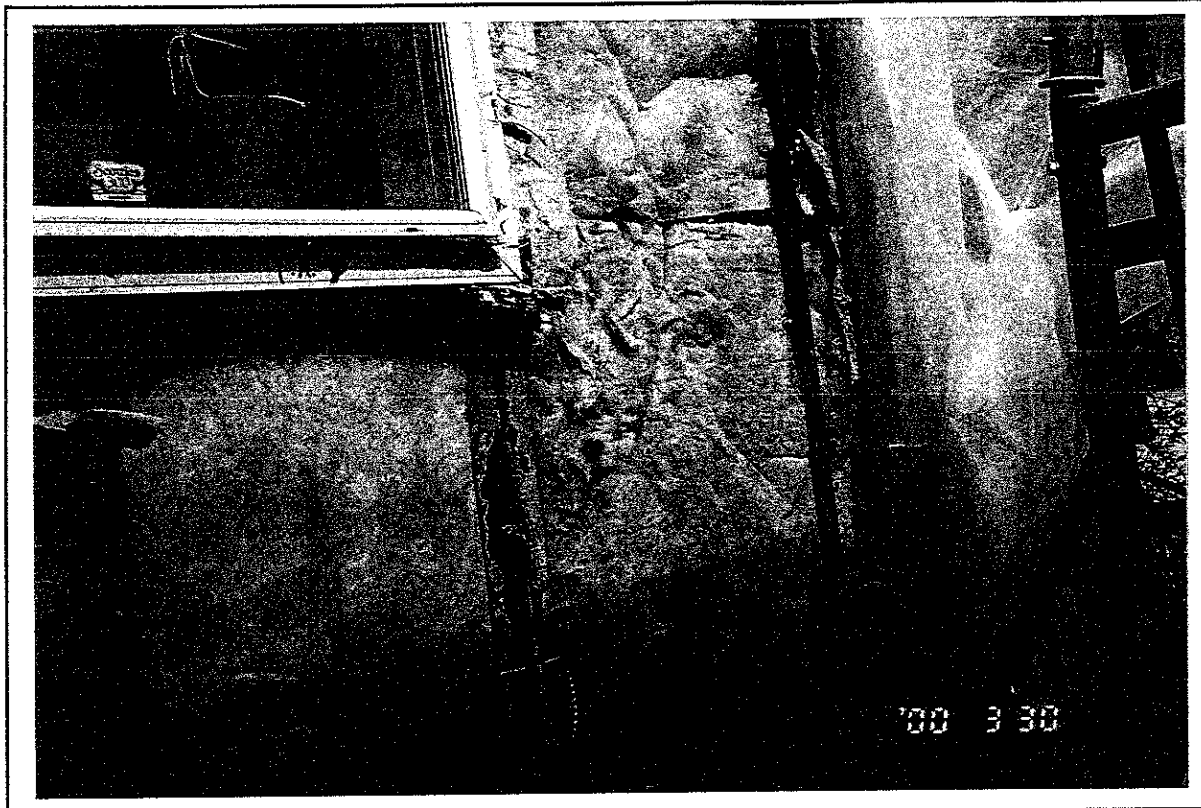
Photo #11 – Test Area #7 – Corroded steel studs

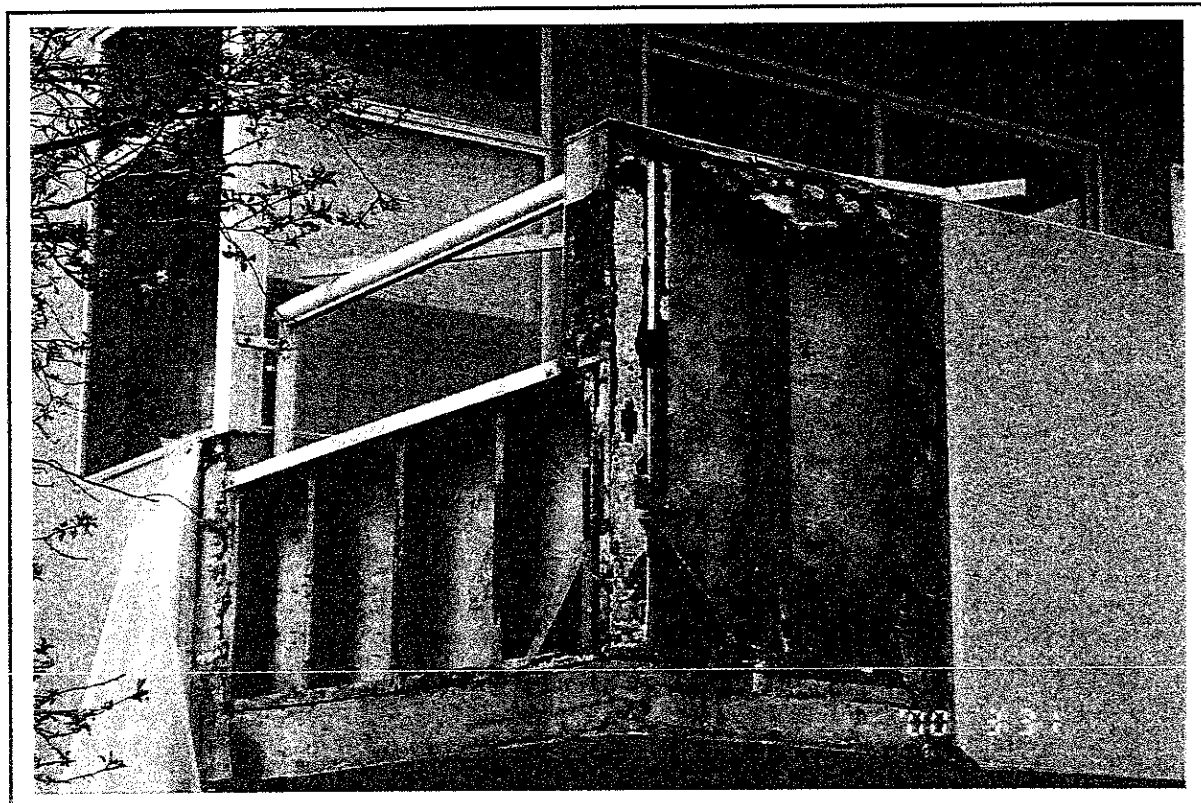
Photo #12 – Test Area #8 – Balcony of 201

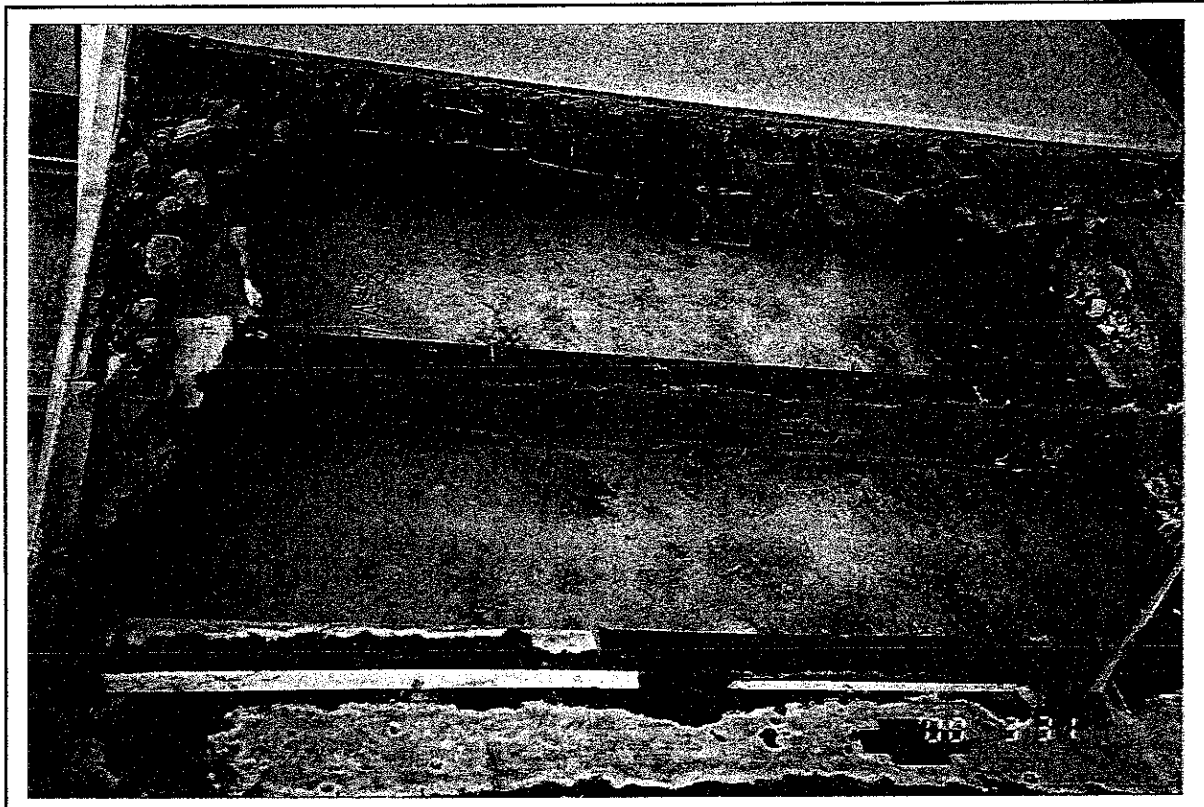
Photo #13 – Test Area #8 – Close-up of corroded steel studs at balcony parapet

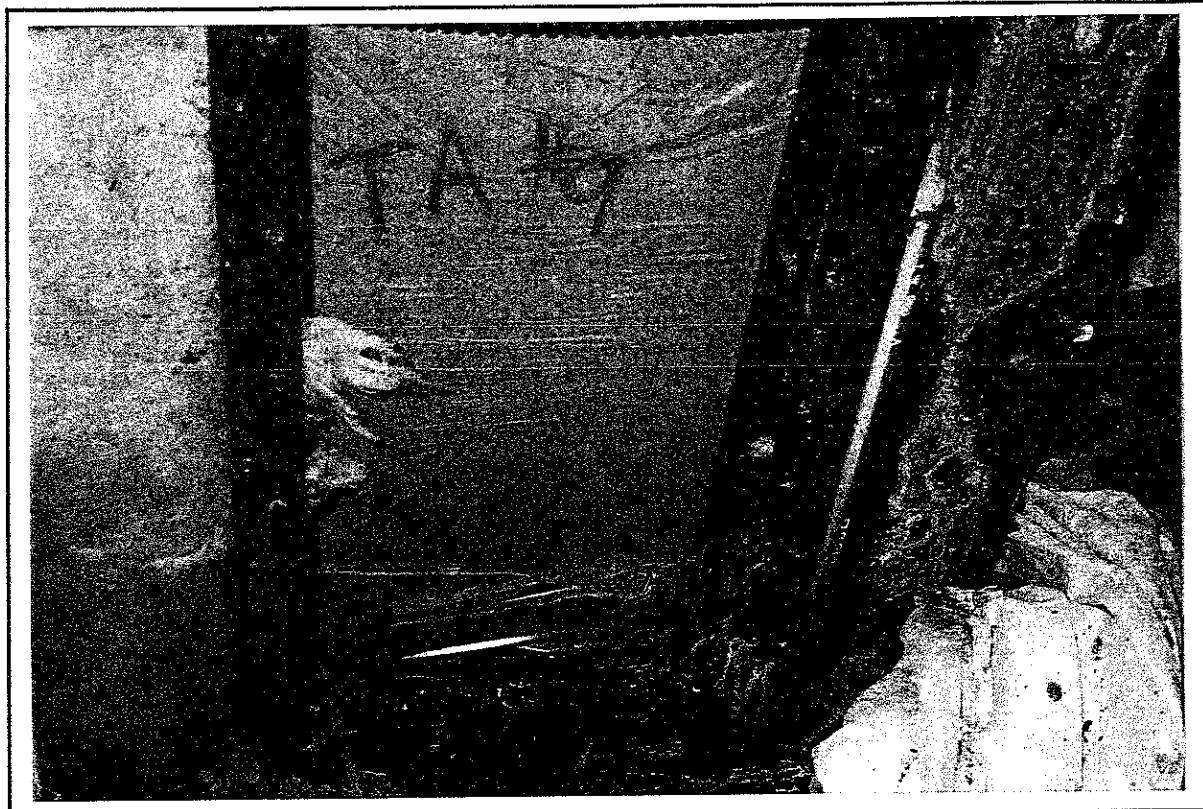
Photo #15 – Test Area #9 – Close-up of corroded steel studs and bottom plate

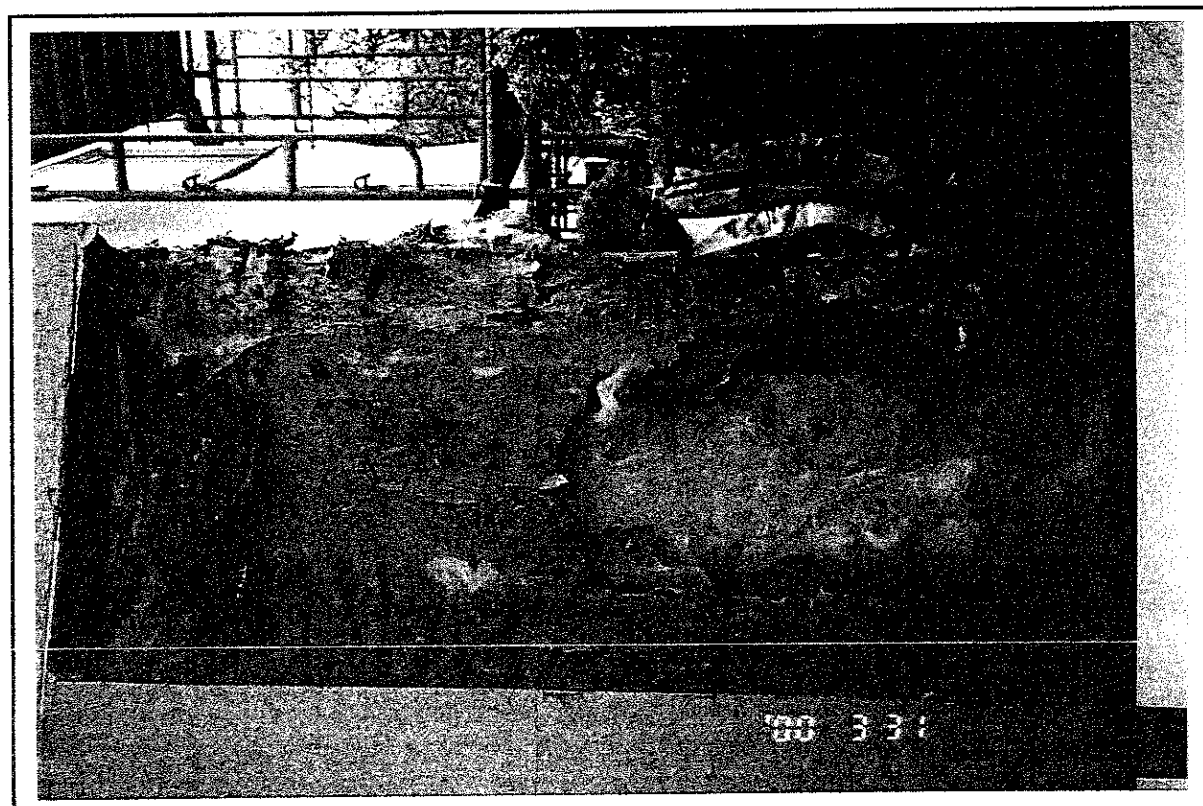
Photo #16 – Test Area #9 – Completely saturated and deteriorated gypsum sheathing

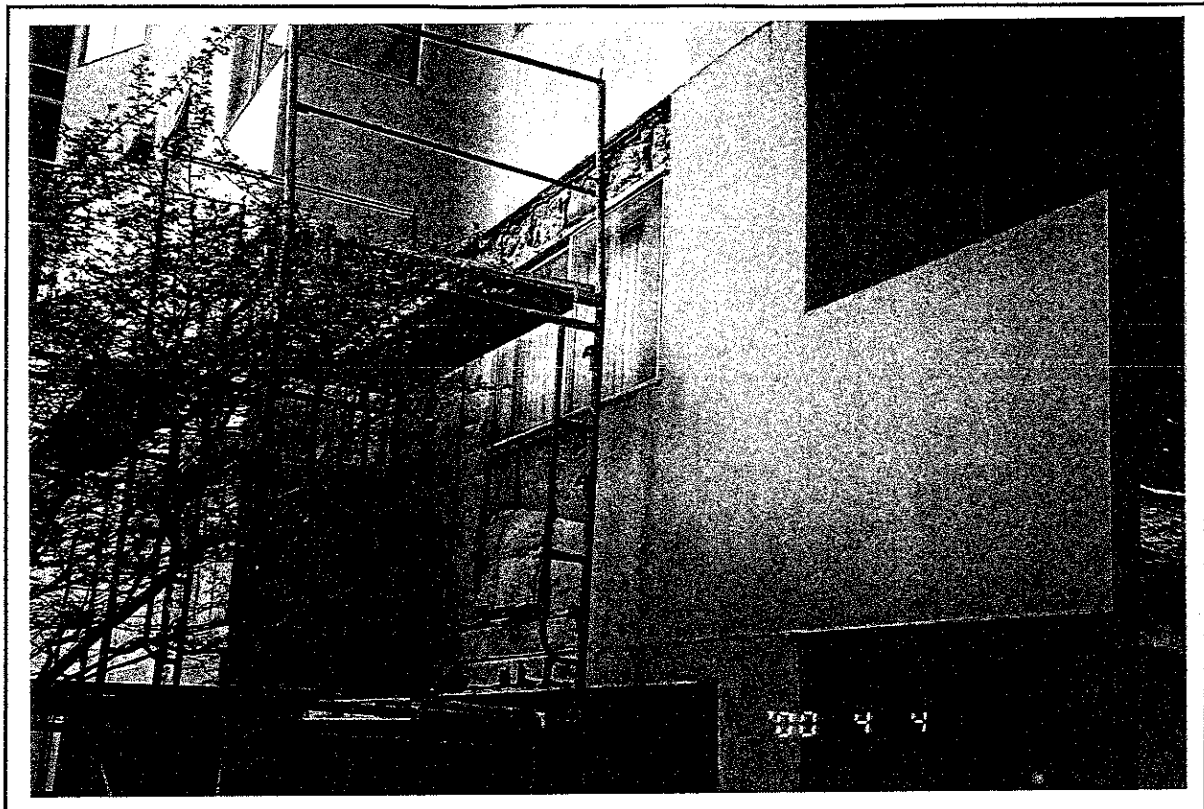
Photo #17 – Test Area #10 – Far-off view of test opening

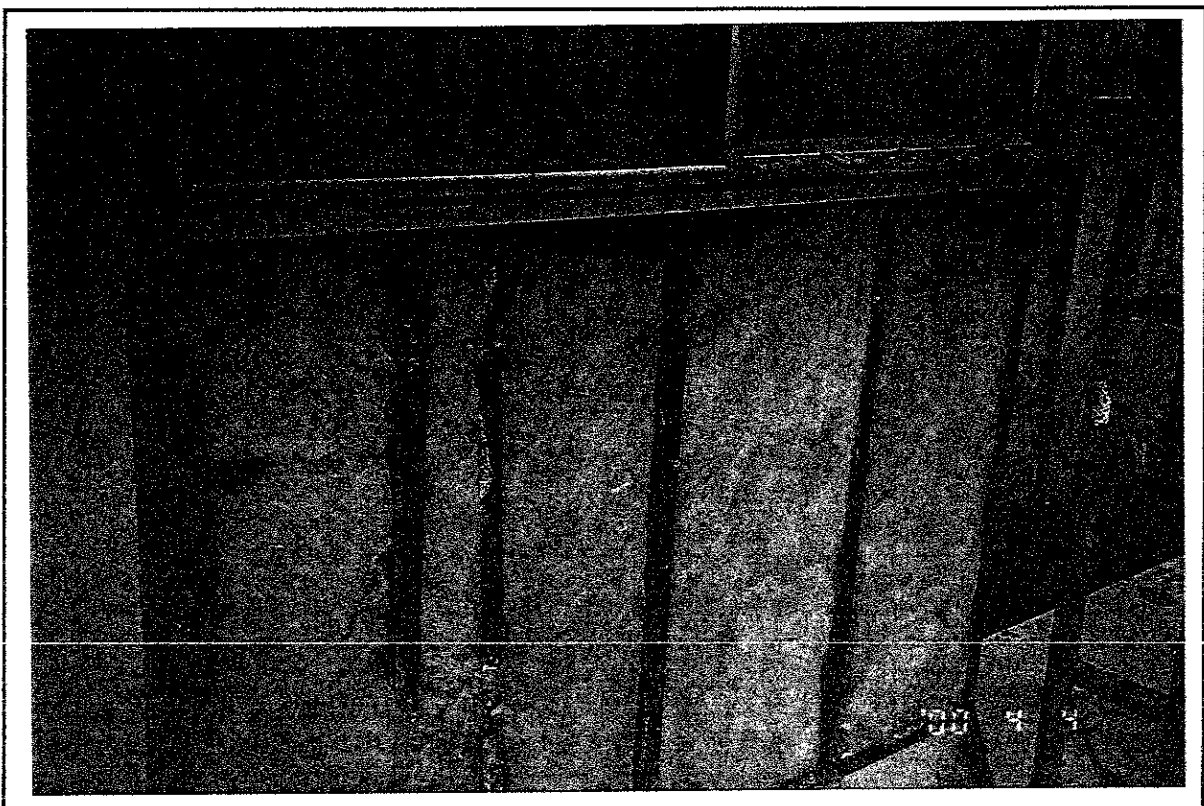
Photo #18 – Test Area #10 – Close-up of corrosion below windows

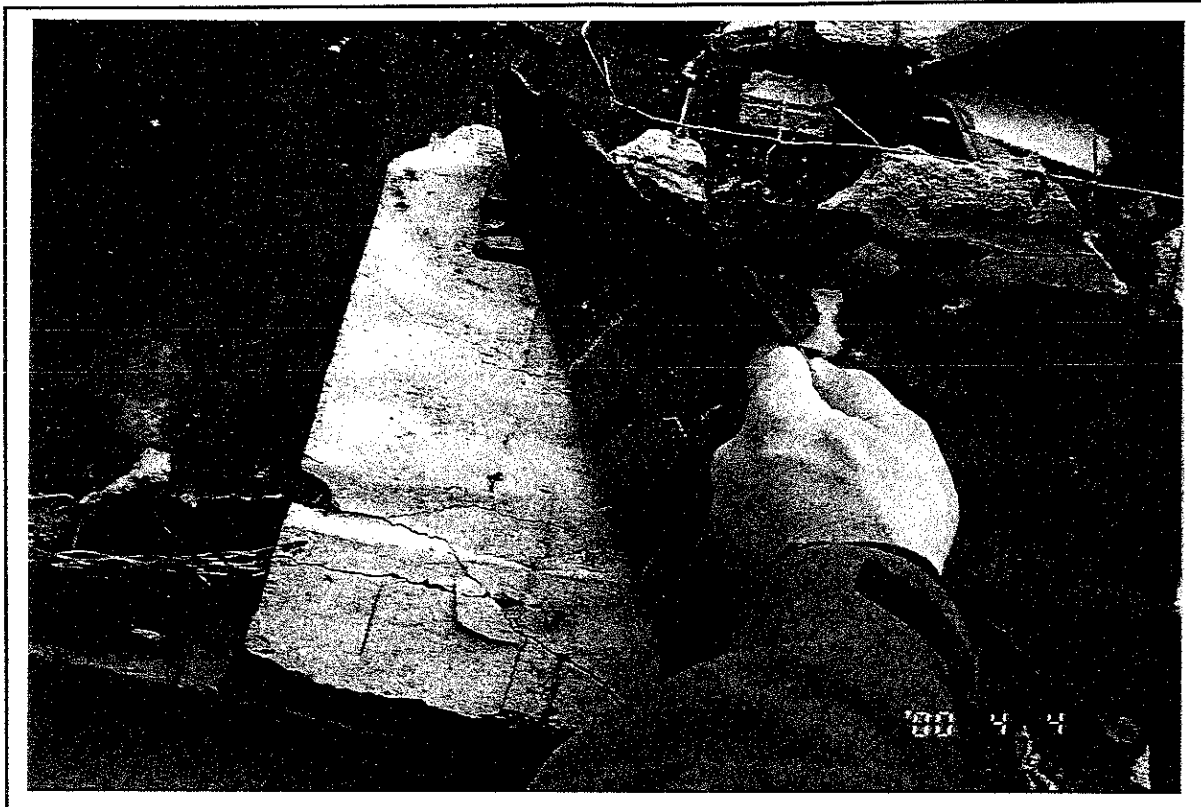
Photo #19 – Test Area #10 – Sheathing paper bonded to backside of stucco

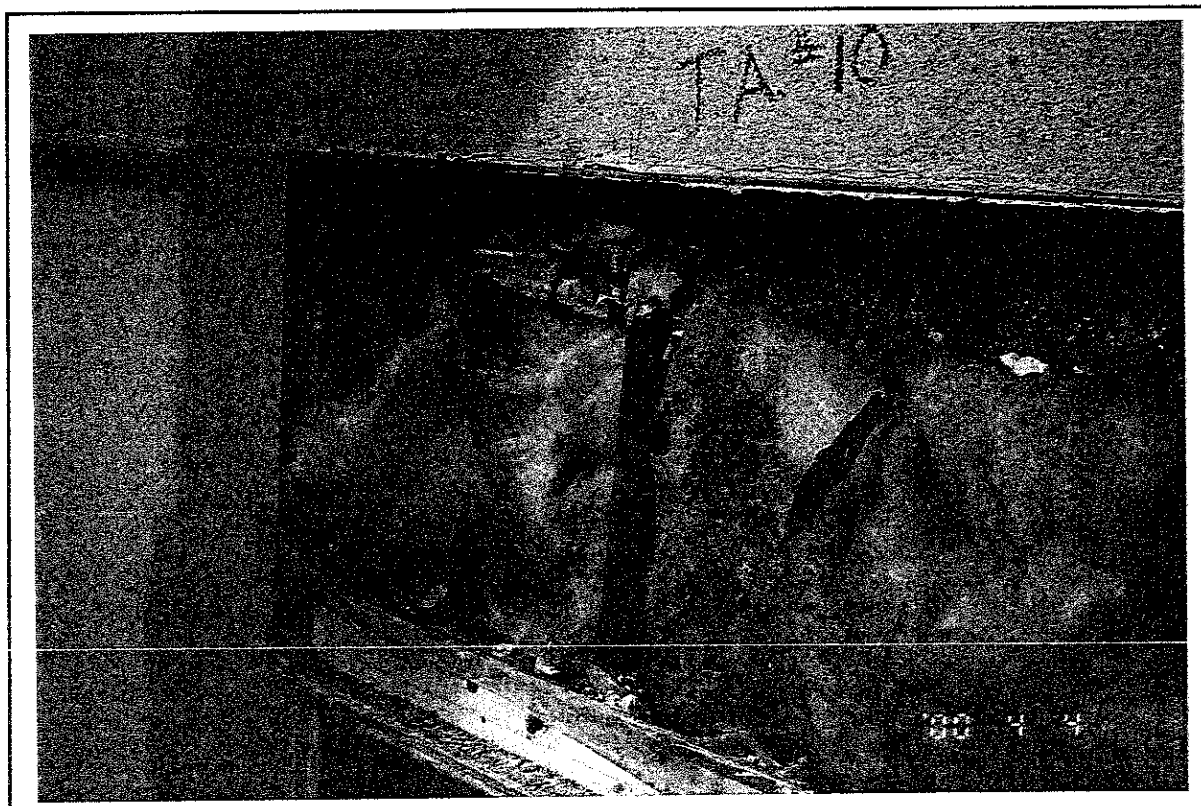
Photo #20 – Test Area #10 – Extensive corrosion above window

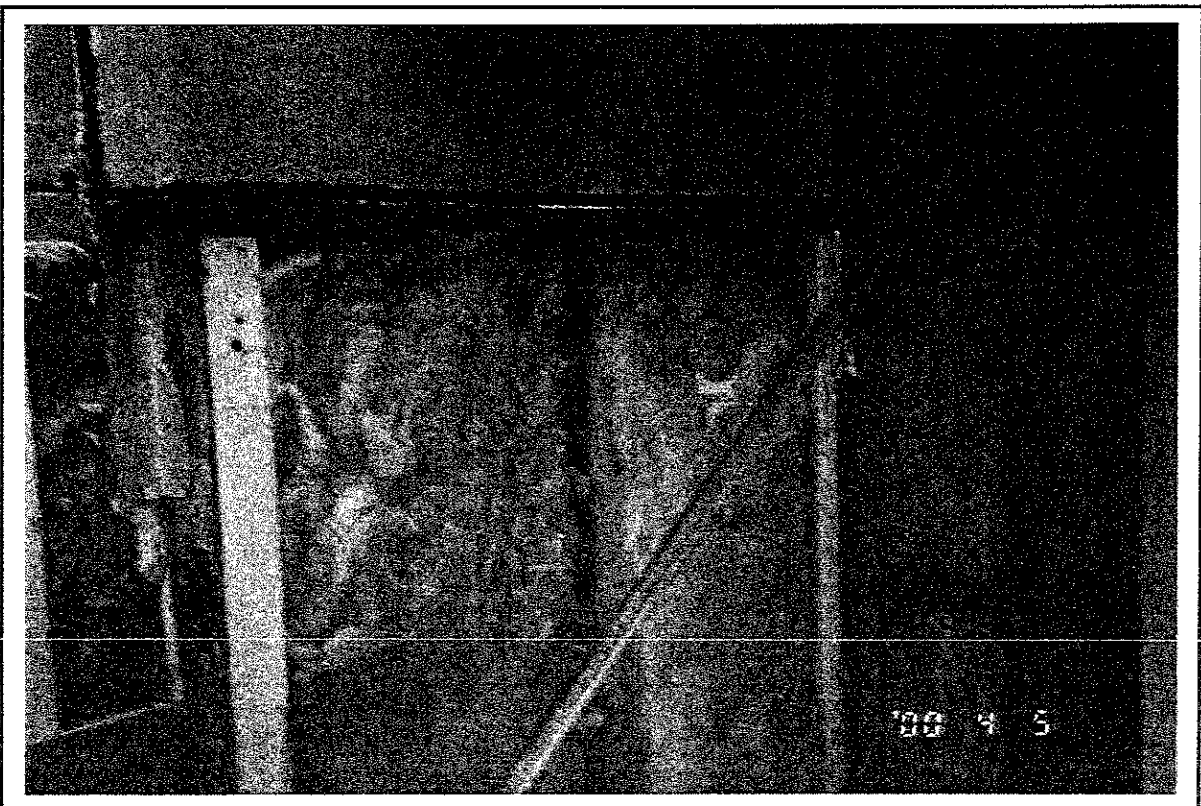
Photo #22 – Test Area #11 – Partial corrosion of steel studs at North wall at corner of balcony 203

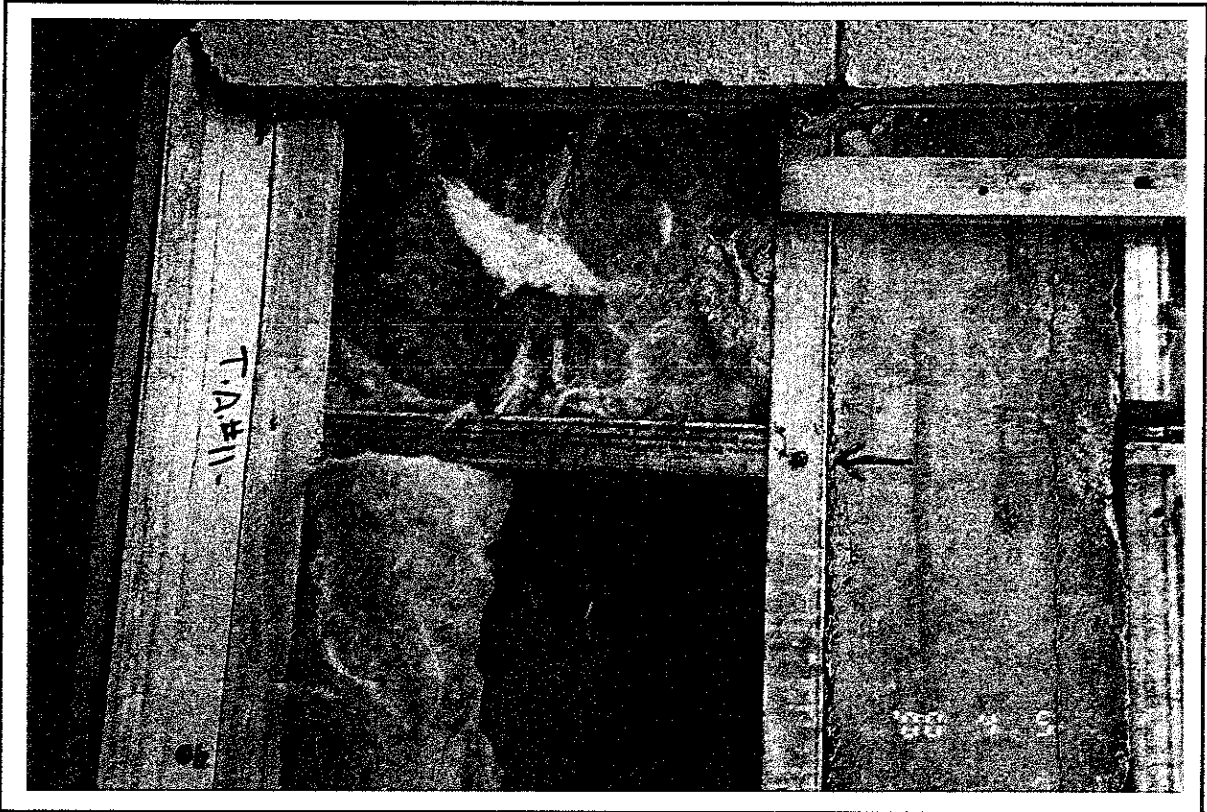
Photo #23 – Test Area #11 – No slip track at steel studs

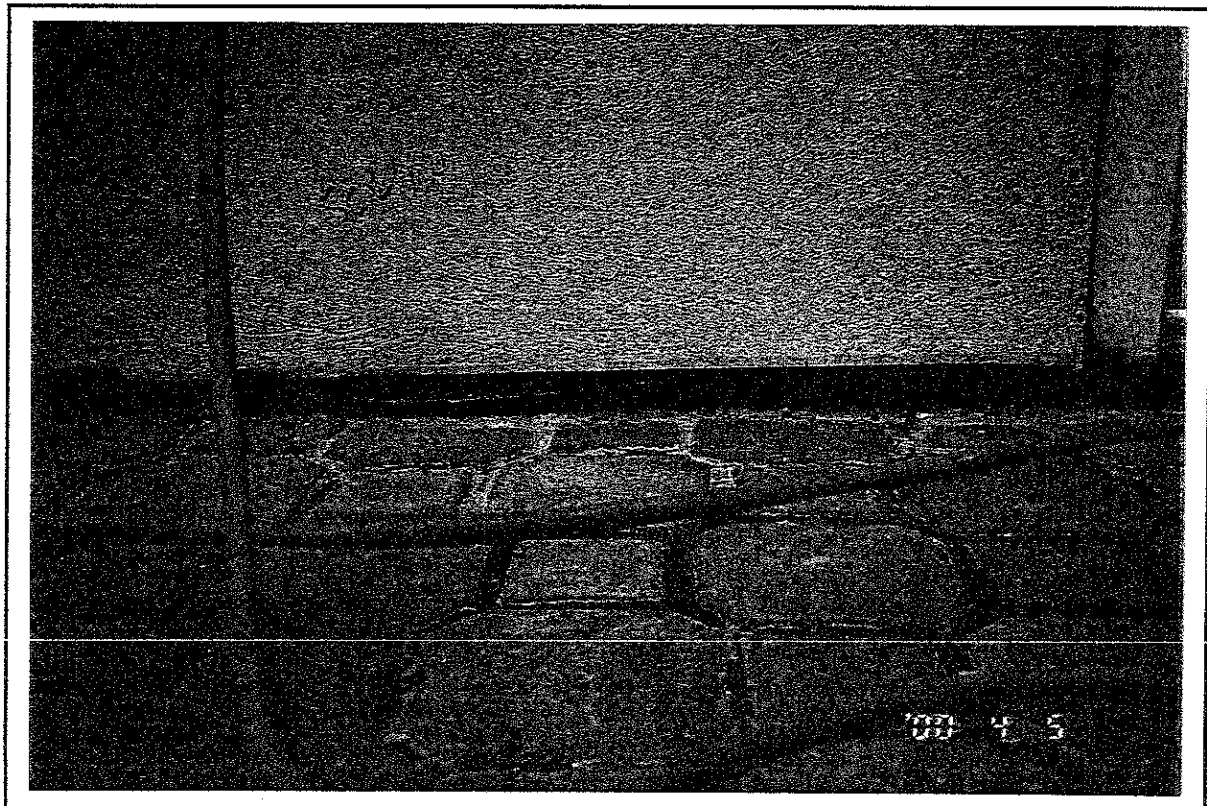
Photo #24 – Test Area #13 – Delaminated membrane at base of wall

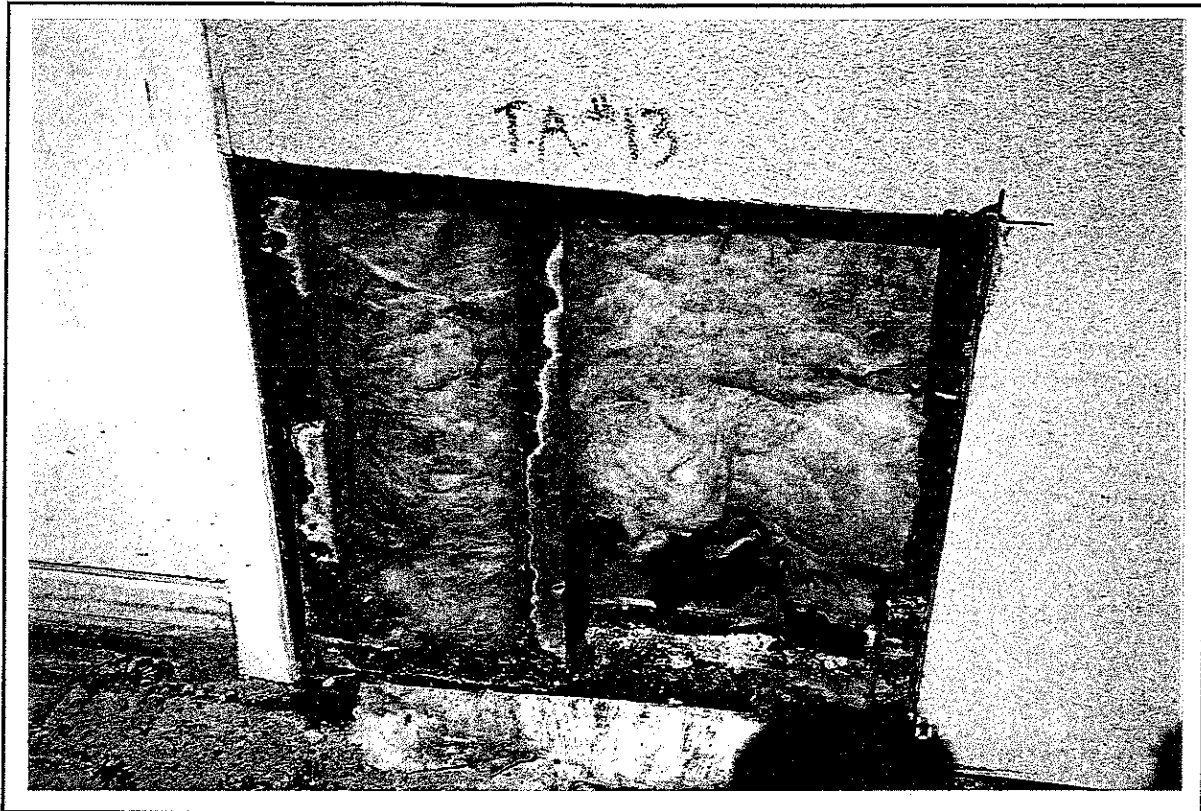
Photo #25 – Test Area #13 – Corrosion of steel studs at base of wall

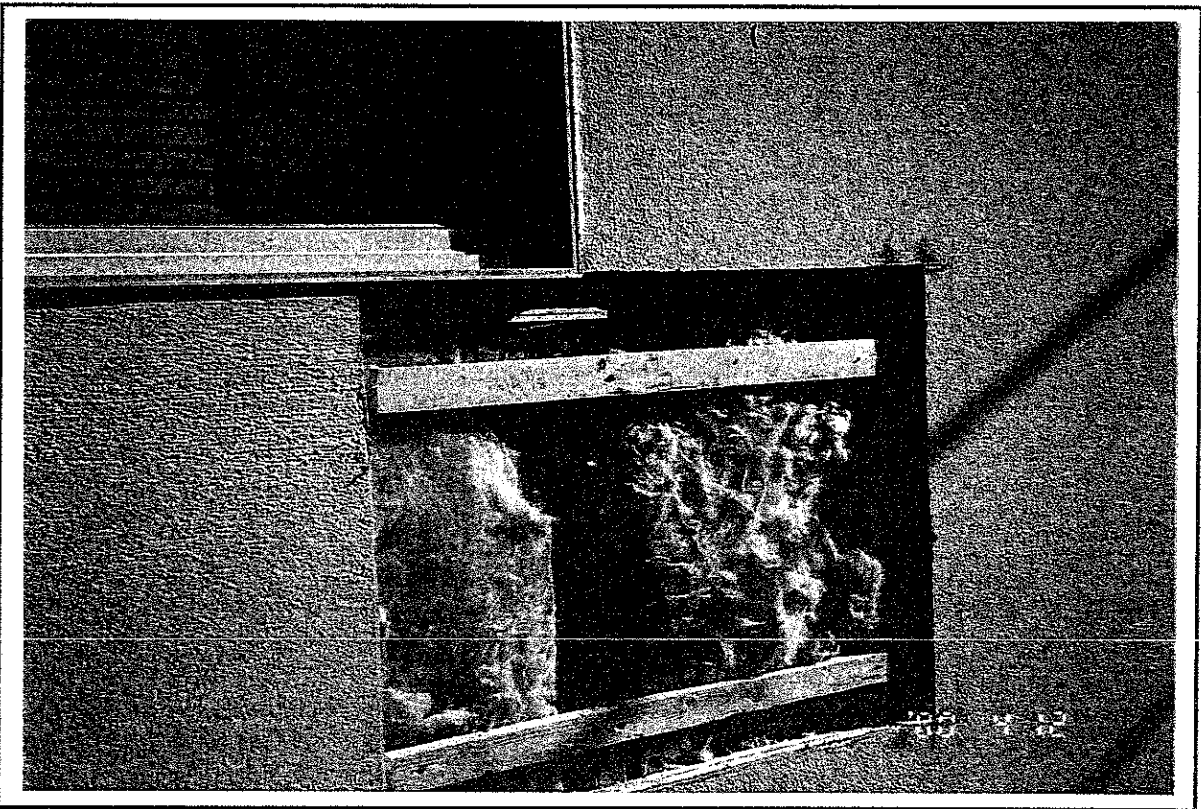
A14	<ul style="list-style-type: none"> <li>▪ Below 2<sup>nd</sup> level window to East side of South exit awning outside bedroom window. (directly above TA #13)</li> </ul>	<ul style="list-style-type: none"> <li>▪ Steel studs below window extensively corroded as well as out in field of stucco (approx 1.5' away from stucco).</li> </ul>	✓
A15	<ul style="list-style-type: none"> <li>▪ North Wall above entry.</li> <li>▪ At East side, a series of small openings below and above North facing windows in exterior (heated) wall and at West facing balcony parapet of 202.</li> </ul>	<ul style="list-style-type: none"> <li>▪ Below and around the North facing windows in the wall area, the gypsum appears in stable condition.</li> <li>▪ No corrosion at the exterior (heated) wall areas noted.</li> <li>▪ Some corrosion noted at opening in West facing balcony parapet, however not to the same extent as other balcony openings.</li> </ul>	✓

Photo #26 – Test Area #14 – Corrosion of steel studs just to East of Test Area #6

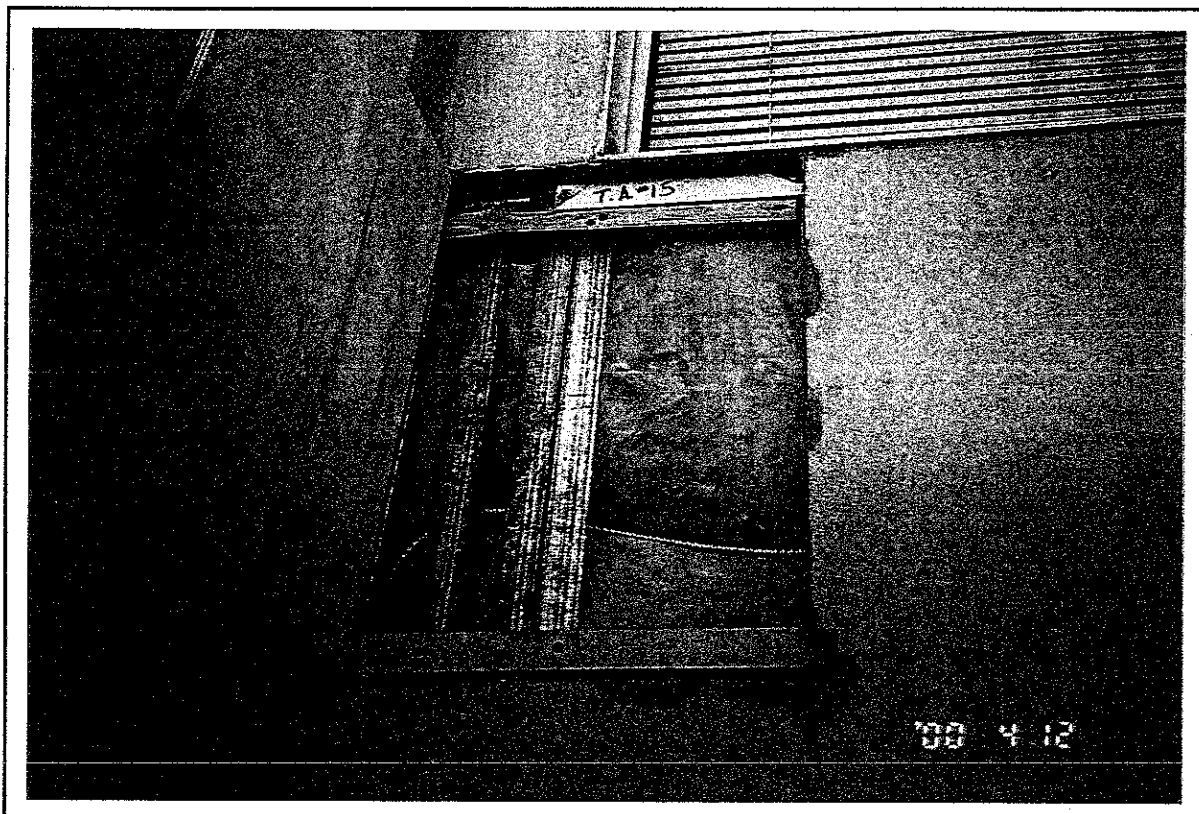
Photo #27 – Test Area #15 – North wall, West of entry
