### **APPENDIX A – BC BUILDING SCIENCE EXTERIOR TEST AREA OBSERVATIONS**

### **APPENDIX C – PHOTOGRAPHS**

Westview Place

1166 West 11<sup>th</sup> Avenue, Vancouver

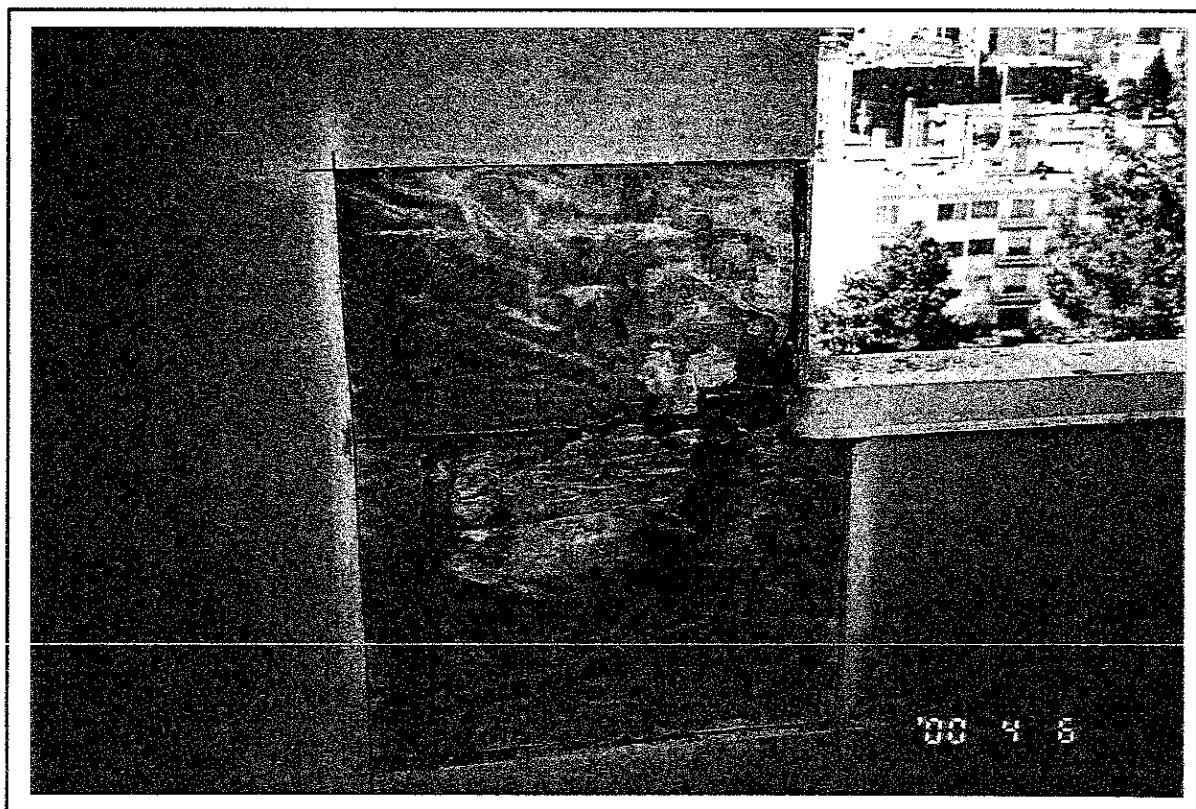
A16	<ul style="list-style-type: none"> <li>▪ Roof Level: East wall, North end at roof parapet to exterior wall saddle interface outside 1002.</li> </ul>	<ul style="list-style-type: none"> <li>▪ Gypsum saturated and crumbly when stucco removed.</li> <li>▪ Sheathing paper bonded to stucco.</li> <li>▪ Studs in exterior wall badly corroded.</li> <li>▪ Roof parapet fabricated of steel studs and gypsum with stucco finish on both sides.</li> <li>▪ Steel framing in parapet also corroded.</li> </ul>	✓

Photo #28 – Test Area #16 – Mouldy / saturated gypsum sheathing

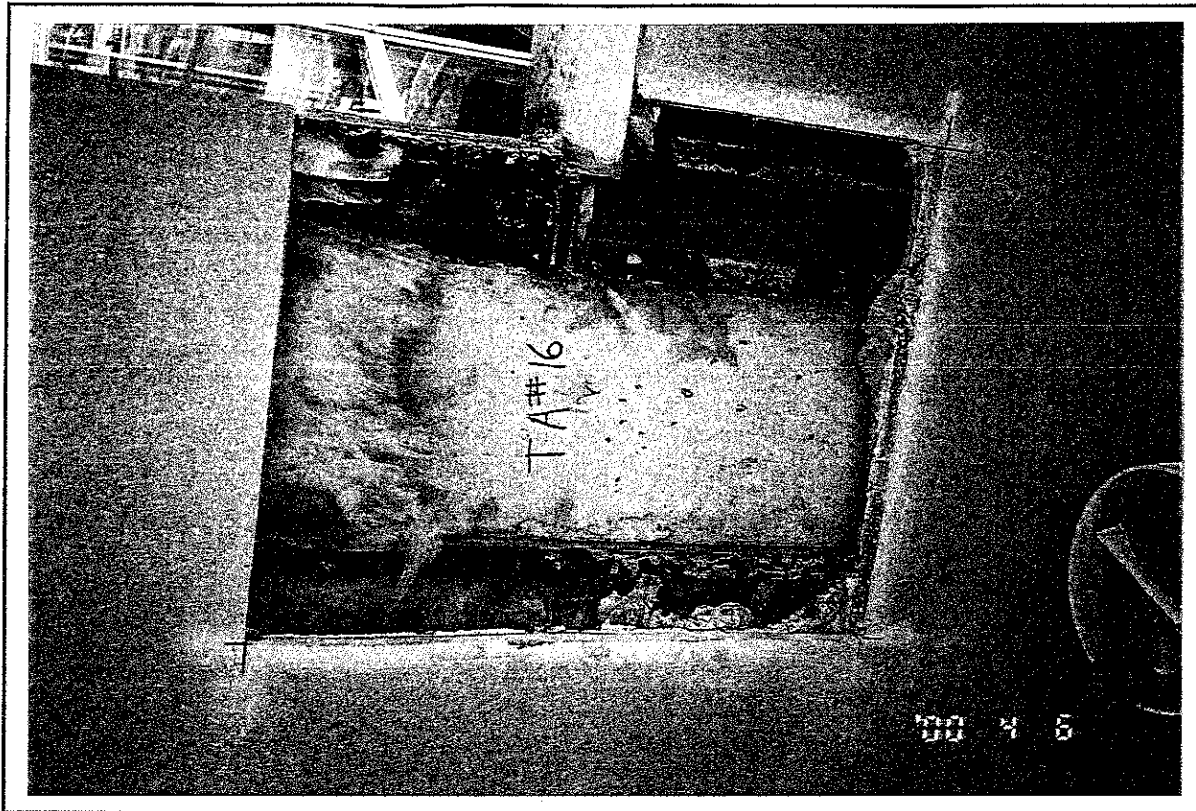
Photo #29 – Test Area #16 – Corroded steel studs

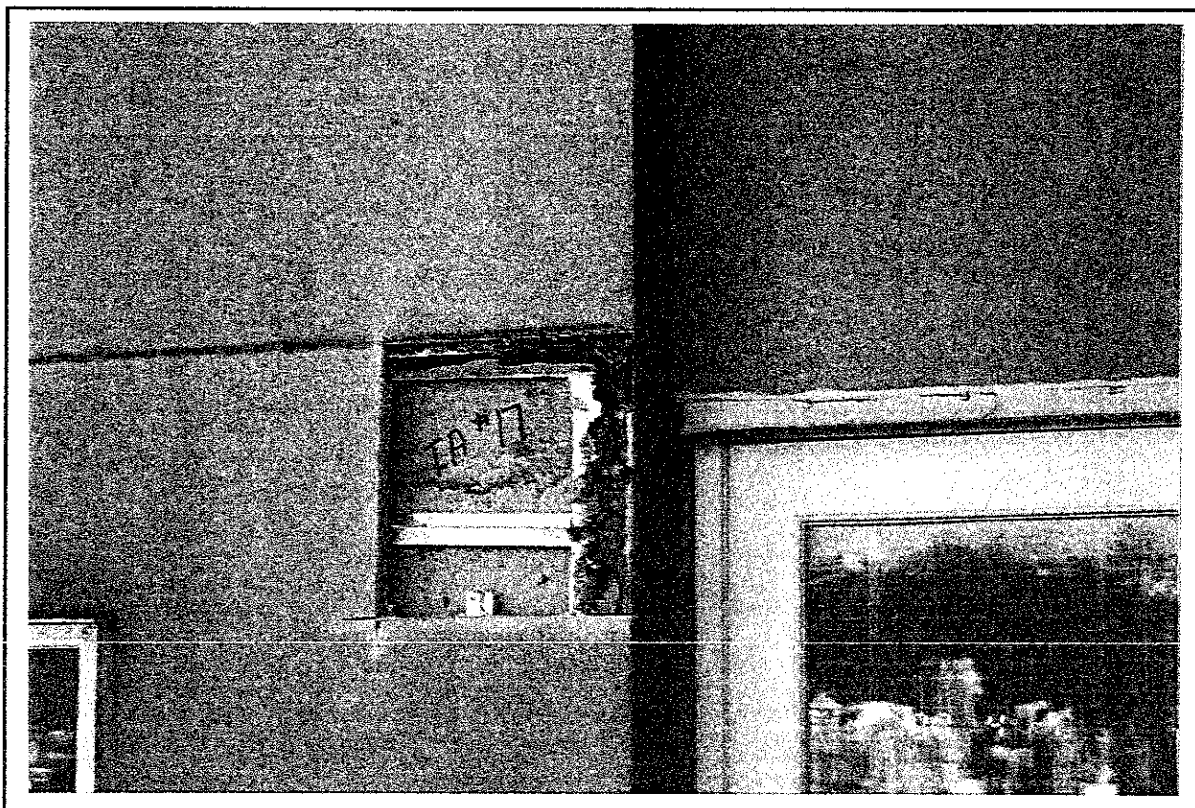
A17	<ul style="list-style-type: none"> <li>▪ Roof Level: West end of East wall, above door to deck of Unit 1001.</li> <li>▪ Test opening located at concrete shear wall.</li> </ul>	<ul style="list-style-type: none"> <li>▪ Wood framed door badly deteriorated.</li> <li>▪ No corrosion of metal furring noted.</li> </ul>	
A18	<ul style="list-style-type: none"> <li>▪ Roof Level: Middle of East wall, directly beside roof access door.</li> </ul>	<ul style="list-style-type: none"> <li>▪ Gypsum sheathing totally saturated.</li> <li>▪ Extensive corrosion of the steel studs noted.</li> </ul>	✓
A19	<ul style="list-style-type: none"> <li>▪ Roof Level: West wall beside deck door to Unit 1003 at curved stair wall.</li> </ul>	<ul style="list-style-type: none"> <li>▪ Gypsum has a few minor moisture stains, but in generally stable condition.</li> <li>▪ No signs of corrosion activity on steel framing.</li> </ul>

Photo #30 – Test Area #17 – Concrete column / furring in good condition

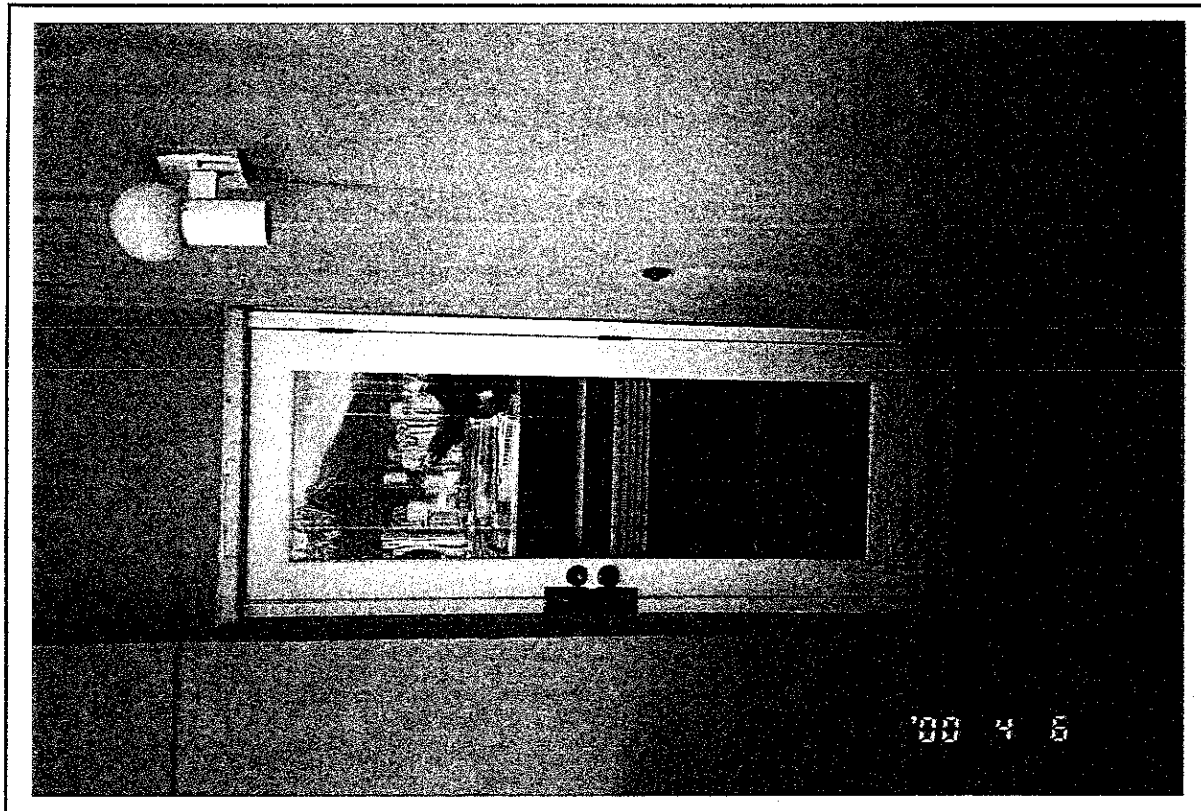
Photo #31 – Test Area #17 – Deteriorated wood door at deck of 1001

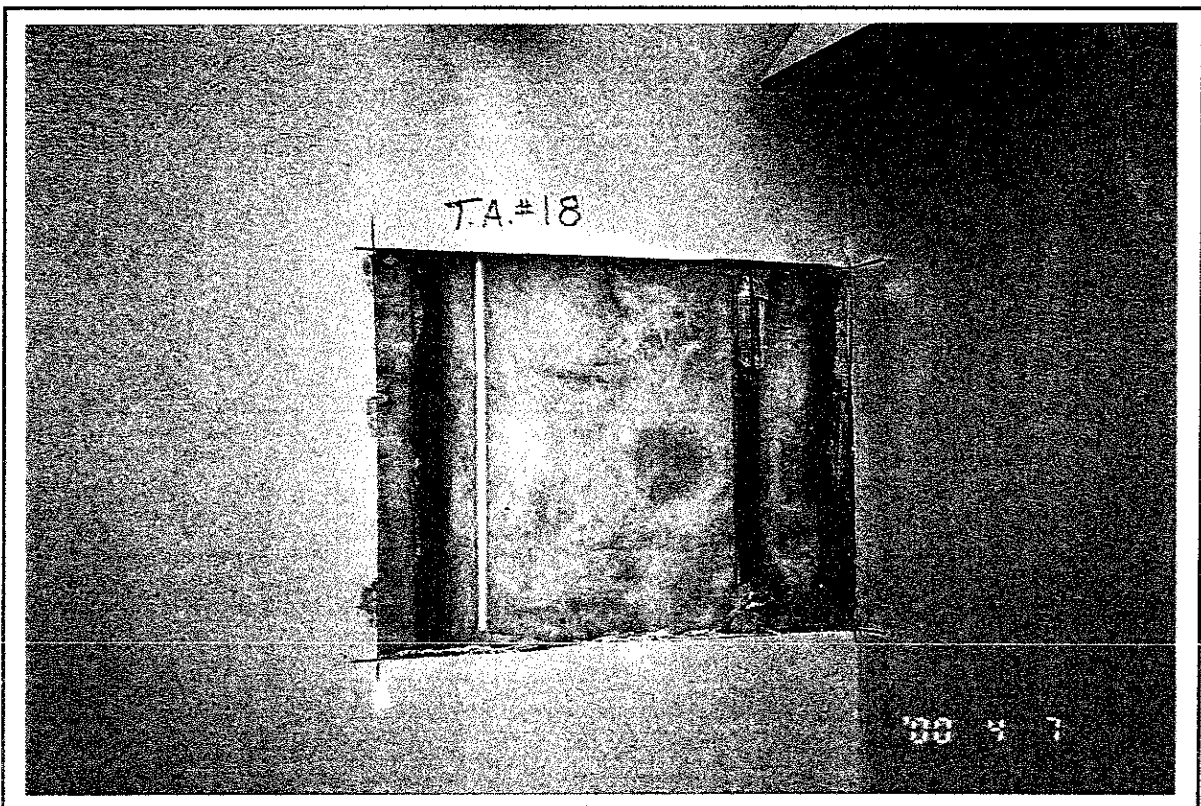
Photo #32 – Test Area #18 – Corroded steel studs to North of East roof access door

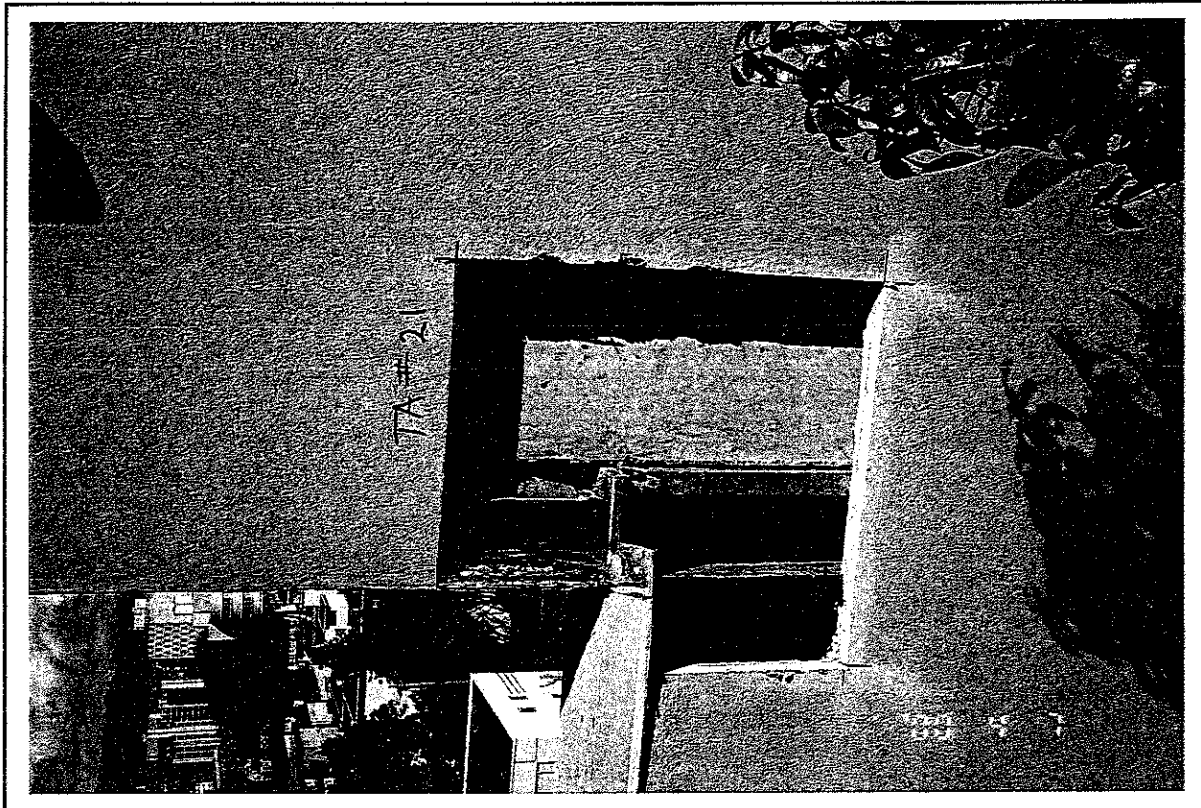
Photo #33 – Test Area #21 – Corrosion at saddle interface of 1003

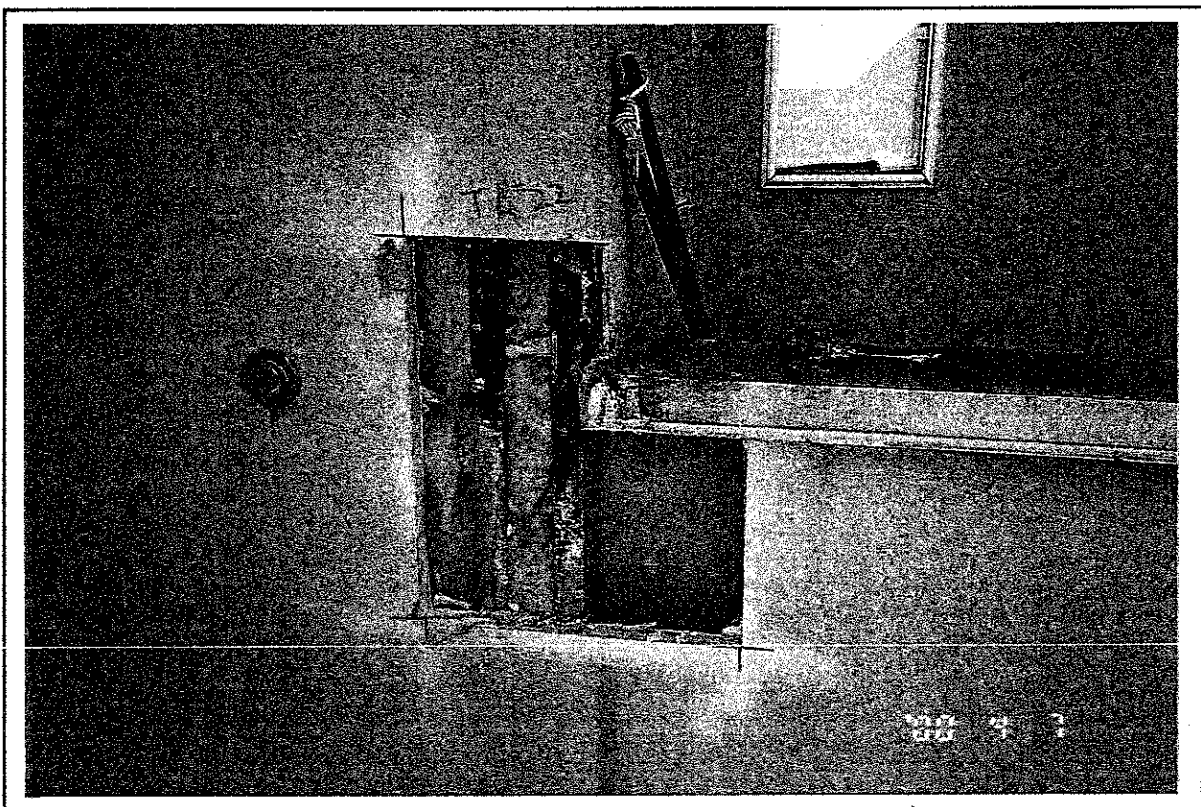
Photo #34 – Mild corrosion at saddle interface of 1002

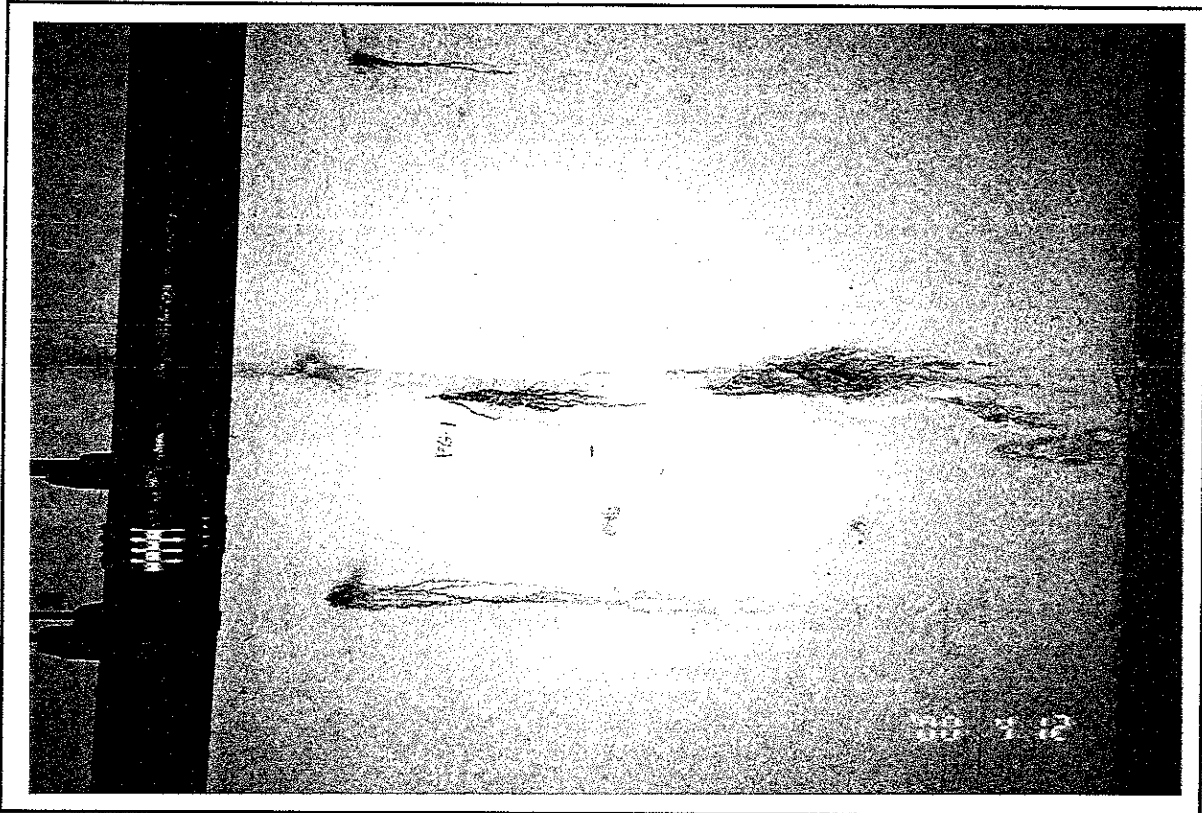
Photo #35 – Leakage at parking garage, West wall
